Evaluation of Trout Habitat Improvement Structures in Three High-Gradient Streams in Wisconsin

Technical Bulletin No. 179
Department of Natural Resources
Madison, Wisconsin
1992

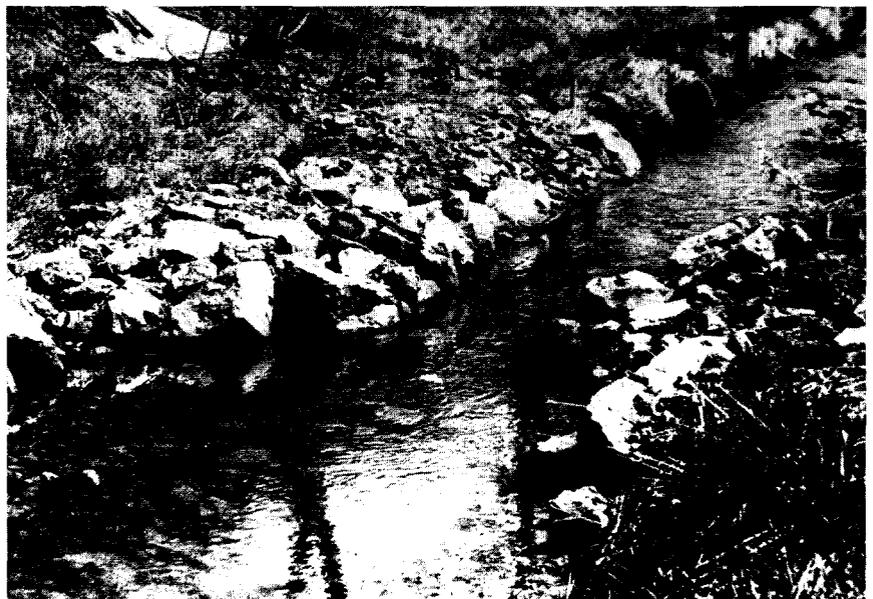
At Camp Creek, an excellent channel constrictor reinforced with large quarry stones produced one of the best pools in the treatment zone.

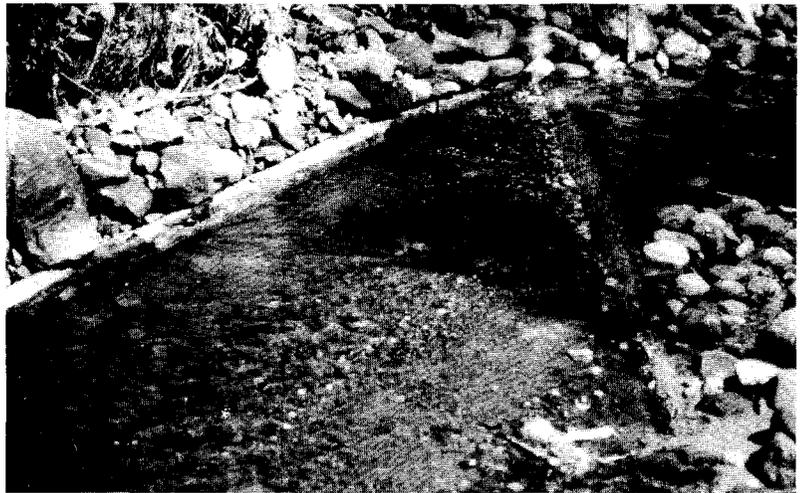
On Twenty Mile Creek, this cross-channel log/bank revetment structure provided an excellent pool and resting/security cover for trout in the treatment zone.

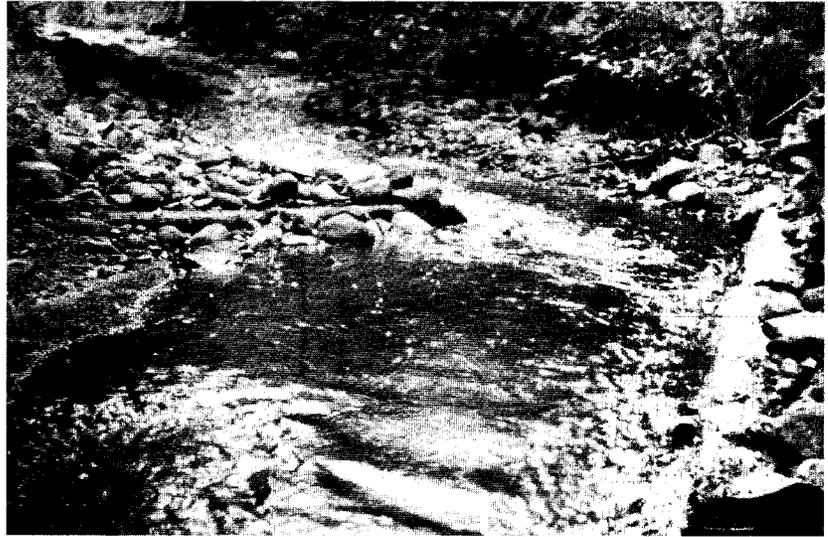
On Twenty Mile Creek, a wing deflector guided stream flow toward a bank cover structure made from 2 large logs cut nearby.
