RESTORING THE RECREATIONAL POTENTIAL OF SMALL IMPOUNDMENTS

The Marion Millpond Experience

*An Inland Lake Renewal
and Management Demonstration
Project Report*

Technical Bulletin No. 71
DEPARTMENT OF NATURAL RESOURCES
Madison, Wisconsin

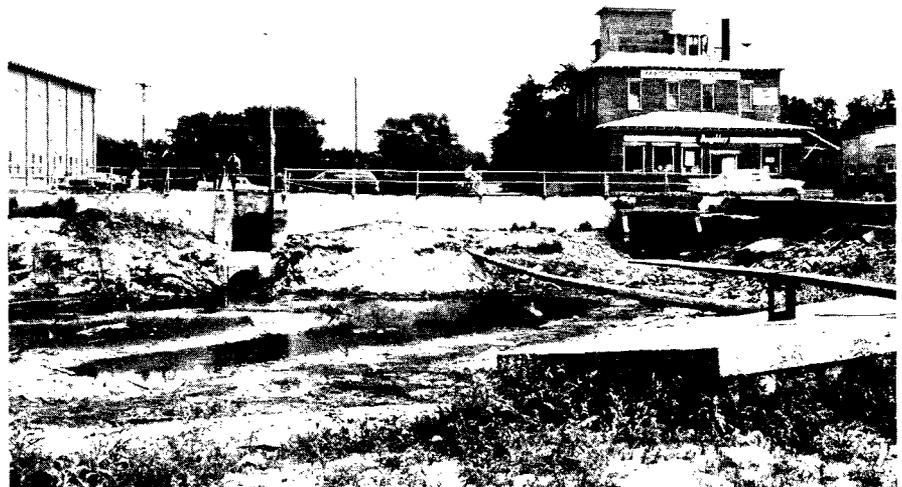
FIGURE 4
The Marion dam showing the emergency wasteway and flume (looking east).

leave behind a permanent facility to drain the pond in the future (Fig. 4).* This work was performed by the citizens of Marion (for less than \$5,000) during May and June 1969, and by late July 1969, the Marion Millpond was drained (Fig. 5).

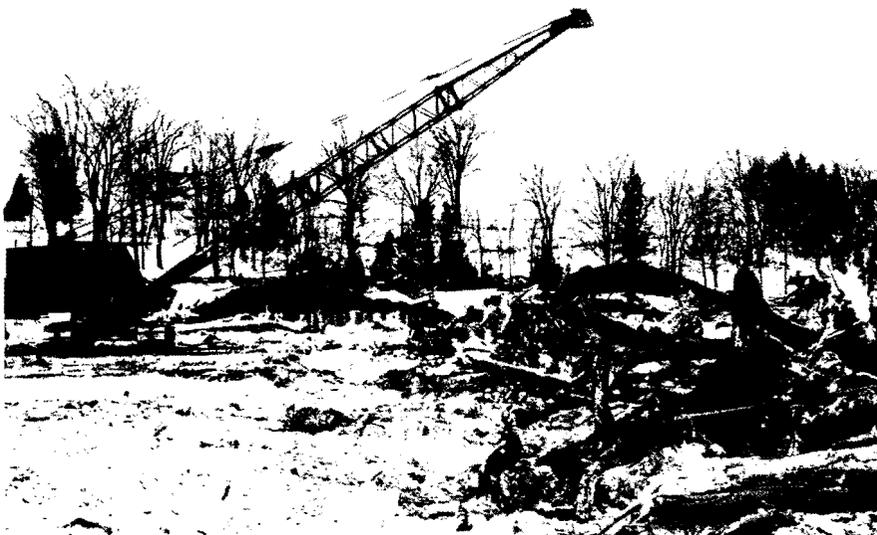
FIGURE 7

Winter stump removal.

During the 1969-1970 winter, roads were frozen-in on the pond bottom. This enabled contracted heavy equipment to work on the pond bottom proper. Deeply embedded logs and stumps were removed by a drag line, wind-rowed by a front-end loader, and moved off the pond bottom by truck. (Fig. 7). The large volumes of stumps and debris were trucked to a disposal area. (In spite of a great deal of thought, no salvage value was found for this wood - largely cedar and

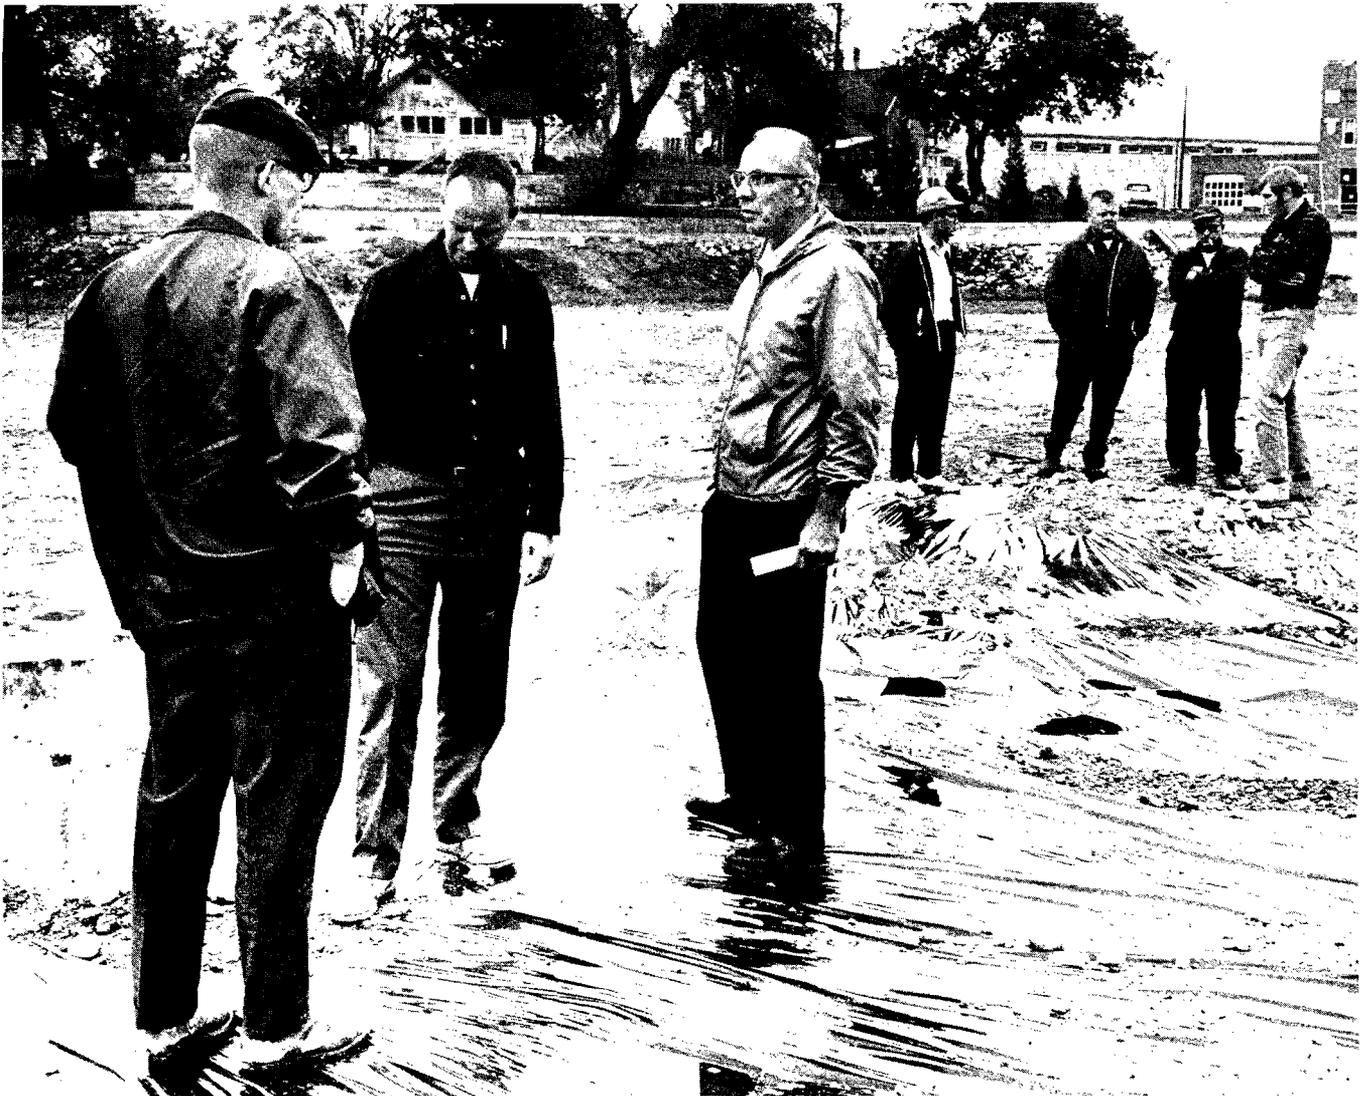
FIGURE 8

Plastic sheeting anchored in place prior to covering.

The plastic sheeting was applied in the winter, when frozen ground and ice cover allowed machinery to be used for transporting and spreading sheeting and anchoring materials. Sheeting was laid down by a team of workers, and anchored temporarily with rocks (Fig. 8). The sheeting was perforated to permit gases from the underlying sediments to escape. From 3-6 inches of sand, gravel or "pit-run" sand and gravel was then spread over the sheeting by means of a front-end

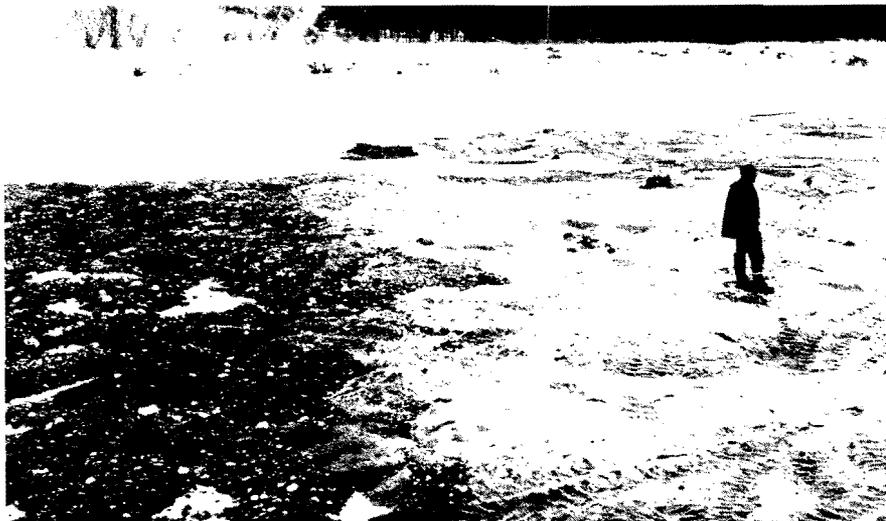
FIGURE 11
Gravel and sand covering over cleared areas.

Other areas of the pond were covered only with sand or gravel for comparative purposes (Fig. 11). The location, description and evaluation of the treated areas are reported in Appendix C and Figure 12.

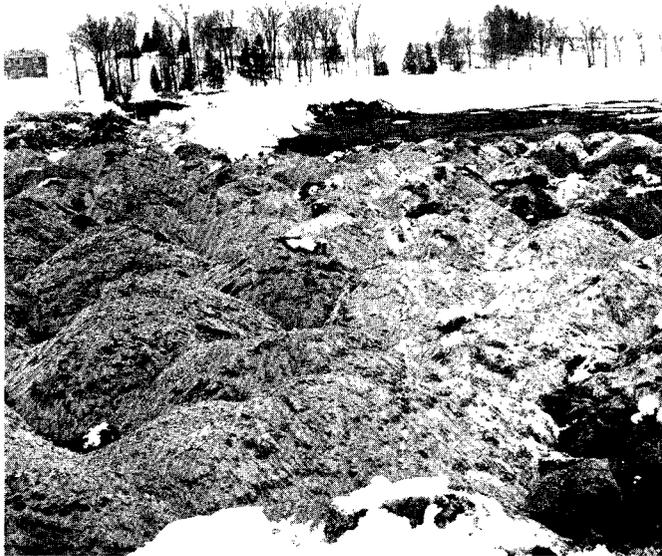
FIGURE 13
Construction of the Lion's Point Beach.

tom, and covered with sand, which was then spread to a 1:8 grade (Figs. 13 and 14). A boat dock was built north of the new beach and picnic tables and other facilities were installed.*

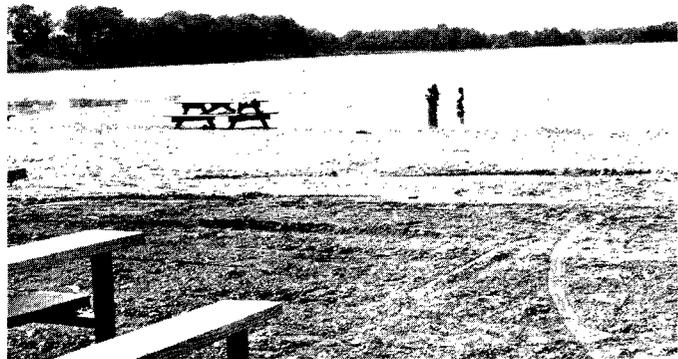
FIGURE 14
Lion's Point Beach - after construction.

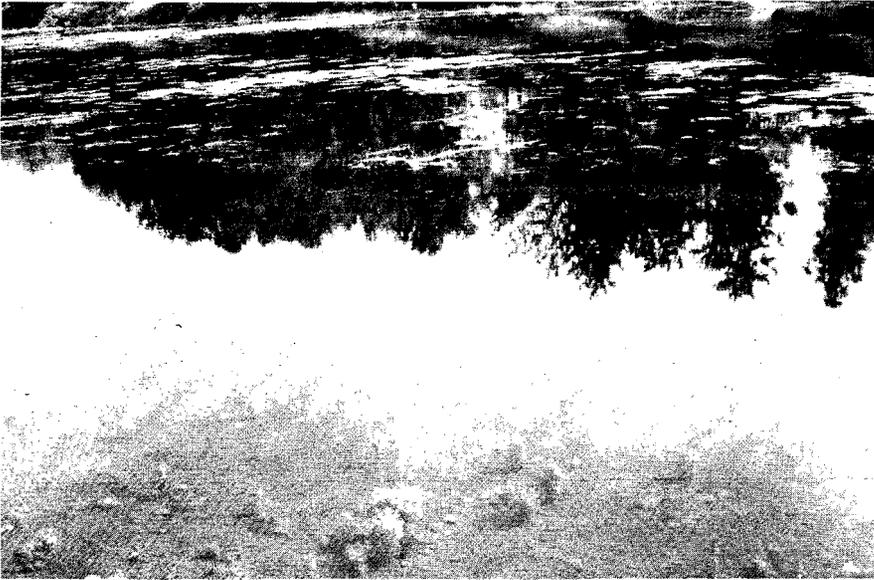
FIGURE 15
 Plant growth in treated areas (foreground) vs. untreated areas during the second year after treatment.

Based upon this two-year comparison, treated areas generally exhibited less plant growth than untreated areas (Fig. 15). Data for 1972 indicate that the areas that were blanketed with sheeting and sand or gravel had substantially less growth than those areas which were only dredged or dredged and sandblanketed; an exception to this occurred where dredging was done to a depth exceeding the photic zone (Treatment 9, see Appendix C). Treated areas have a different vegetation than the control areas. Macrophytic algae of the genus *Chara* form the majority of the plant growth in the treated areas. In contrast, rooted angiosperm macrophytes constitute most of the plant growth in control areas. The shallow-water treated areas had a high biomass of filamentous algae in 1971. Production of this algae dropped off markedly from 1971 to 1972, although small amounts were present clinging to plant tops and shoreline areas. The decrease in filamentous algae was expected, in view of competition from the higher biomasses of other plants in 1972.
