## A Review of Fisheries Habitat Improvement Projects in Warmwater Streams, with Recommendations for Wisconsin

Technical Bulletin No. 169  
Department of Natural Resources  
Madison, Wisconsin

1990

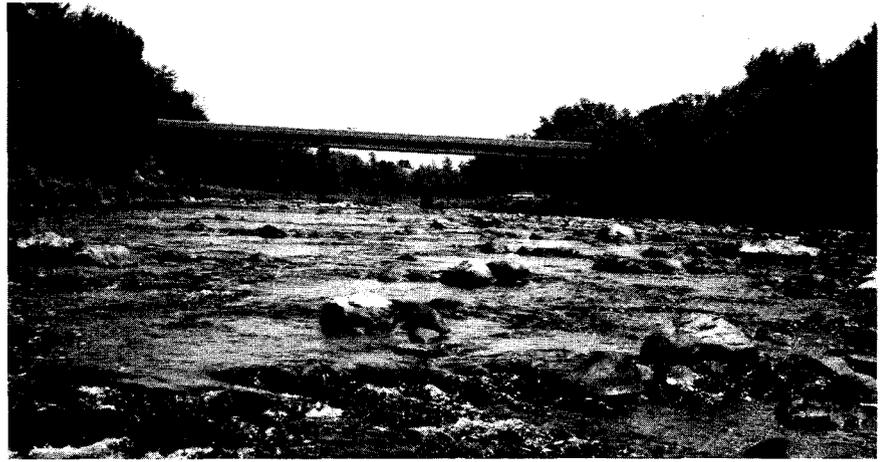
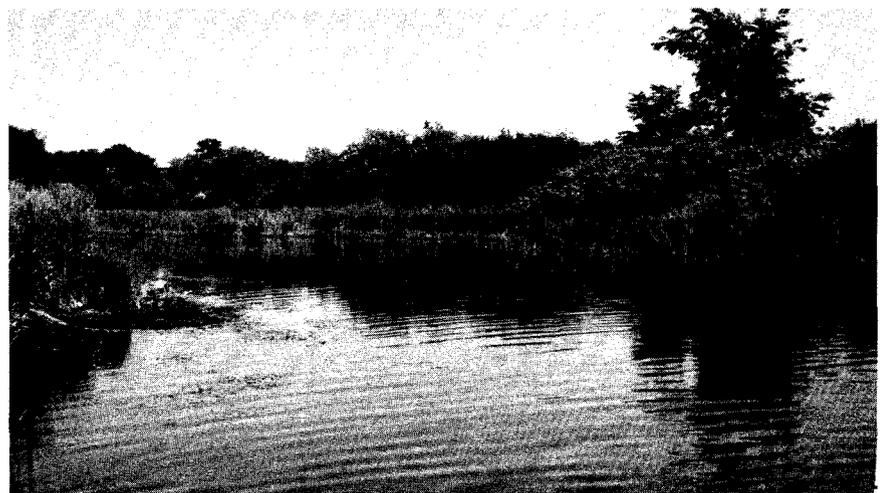
FIGURE 1. Two very different Wisconsin warmwater streams.

(a) Jump River in northwestern Wisconsin. High-gradient and rocky. (Photo by Paul Kanehl.)

(b) Mukwanago River in southeastern Wisconsin. Low-gradient and marshy. (Photo by John Lyons.)

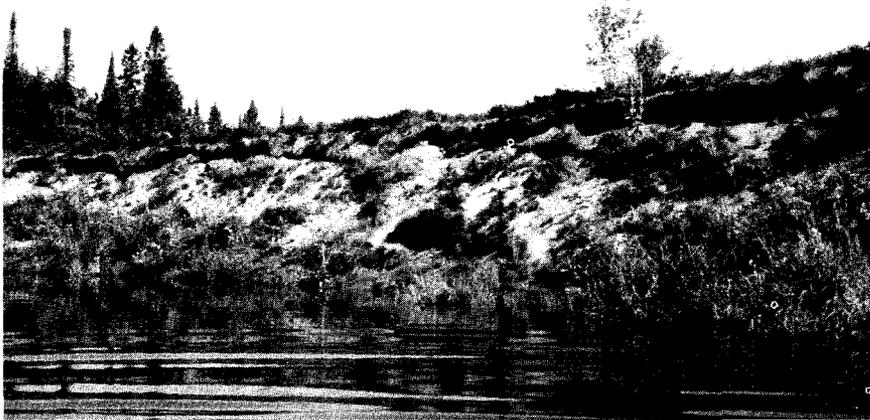
**FIGURE 2.** Severe bank erosion.

(a) North Fork of the Bad Axe River in west-central Wisconsin. (Photo by Paul Kanehl.)

(b) South Fork of the Flambeau River in north-central Wisconsin. (Photo by John Lyons.)

Deposition of fine sediment particles, particularly silt, has well-known negative impacts on fish habitat and fish populations in warmwater streams (e.g., Berkman and Rabeni 1987). Stream bank erosion (Fig. 2) is a major cause of such sedimentation (Roseboom et al. 1983a, 1983b, 1985; Roseboom and Russell 1985). Protection of stream banks can thus significantly reduce erosion and the resulting large sediment loads that lead to deposition (Apmann and Otis 1965, Binns 1986).

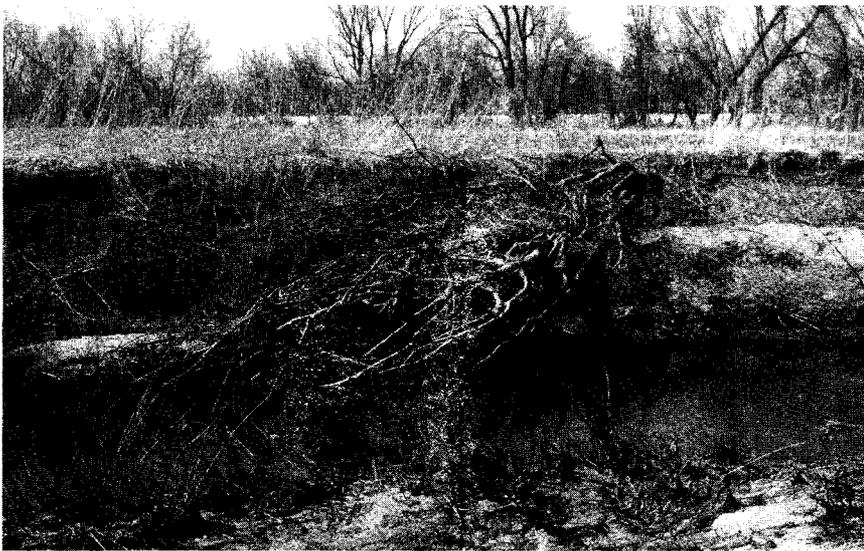
**FIGURE 4.** A tree revetment in Court Creek in west-central Illinois, installed using the George Palmiter river restoration techniques. The revetment has been damaged by ice and only partially protects the severely eroded bank. (Photo by John Lyons.)

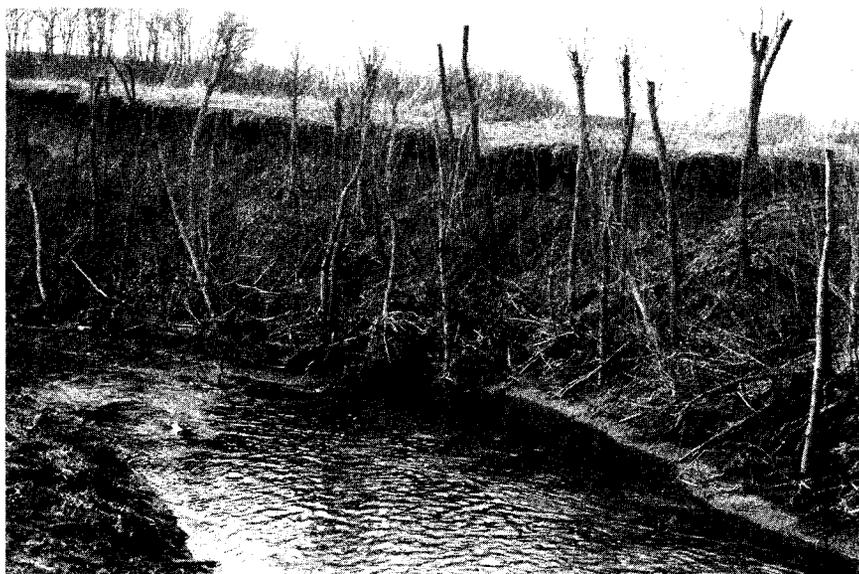
**FIGURE 5.** Using willows to stabilize and revegetate eroded banks.

(a) Willow posts planted to protect eroded banks in Court Creek in west-central Illinois. Pictured in March, these posts were planted about 12 months previously; their root system is already well developed and helps stabilize the bank. They will develop small branches and leaves during the coming spring. (Photo by John Lyons.)

(b) Willow stakes planted to protect eroded banks in the Lamine River, central Missouri. These stakes were planted a few months previously; the ones nearest the water have already begun to sprout. A few partially submerged willow posts can be seen in the upper left-hand corner of the picture. (Photo by Cheryl Courtney.)

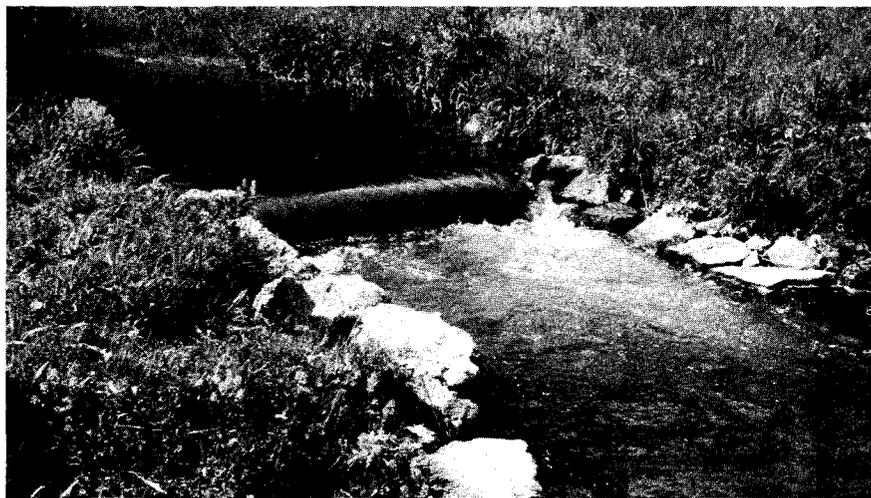
**FIGURE 8.** A Hewitt ramp, a type of low-head dam, in Timber Coulee Creek, a small trout stream in west-central Wisconsin. (Photo by Paul Kanehl.)

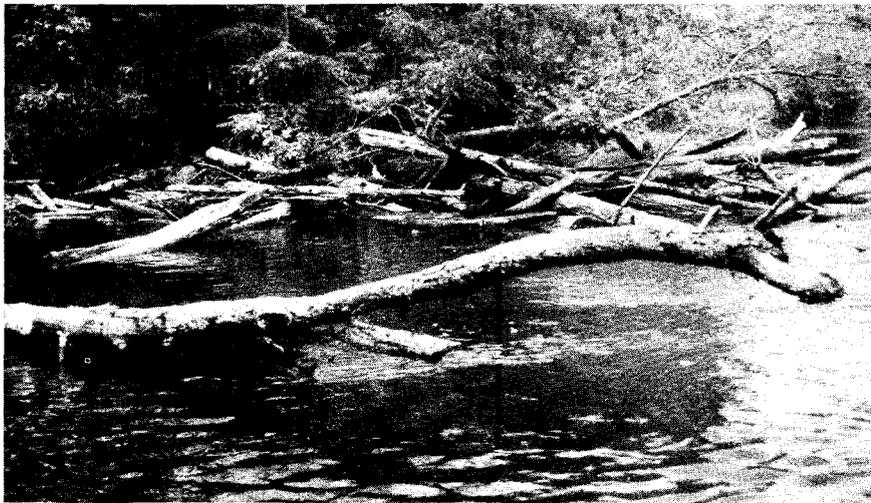
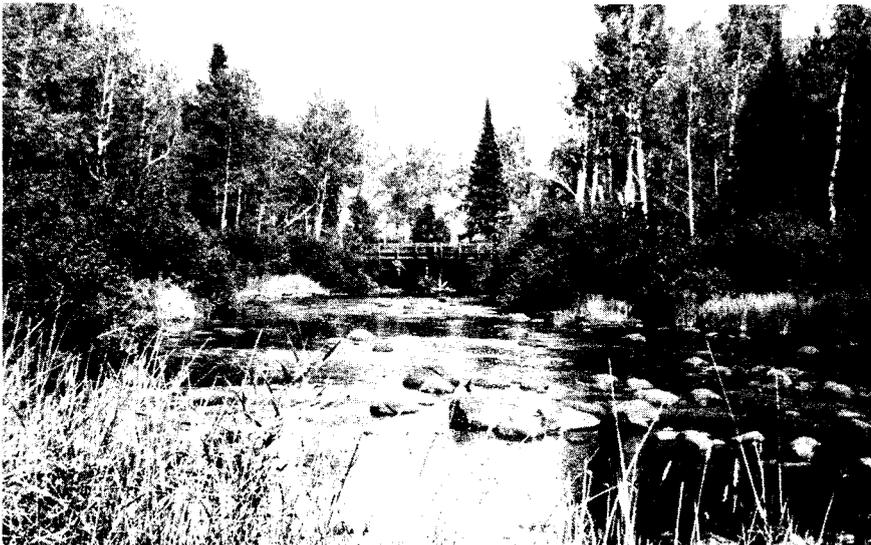
**FIGURE 9.** Some examples of good in-stream cover. (All photos by Paul Kanehl.)

(a) Large woody debris in the Plover River in central Wisconsin.

(b) A macrophyte bed in the Embarrass River in northeastern Wisconsin.

(c) Boulders in the South Fork Flambeau River in central Wisconsin.
